**CANADIAN FORCES
FLIGHT SAFETY INVESTIGATION REPORT (FSIR)**

FILE NUMBER: 1010-149914 (DFS 2-3)
DATE OF REPORT: 22 January 2008

AIRCRAFT TYPE: CH149 Cormorant
DATE/TIME: 0330Z/0030L 13 Jul 06
LOCATION: Over Chedabucto Bay, 2nm north of Canso, NS
N45 22.0 / W061 00.4
CATEGORY: "A" Category Accident

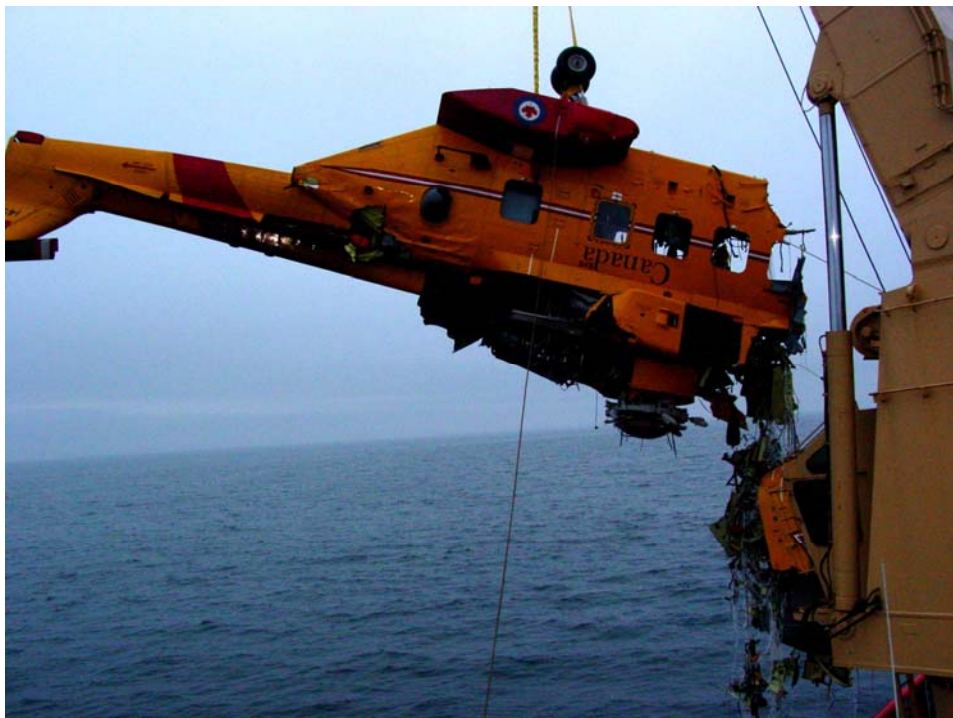
The helicopter was damaged beyond economical repair during the crash. The forward area, including the entire cockpit area, broke away from the rest of the helicopter at the lower forward modular joint X4859 and the upper forward modular joint X4200 (just forward of the right hand cargo door). The airframe separated fairly cleanly. A number of the lift beams in the area of the break showed significant cracking and the one nearest the cargo door was completely fractured.

Photograph 2: Damaged fuselage of CH149914

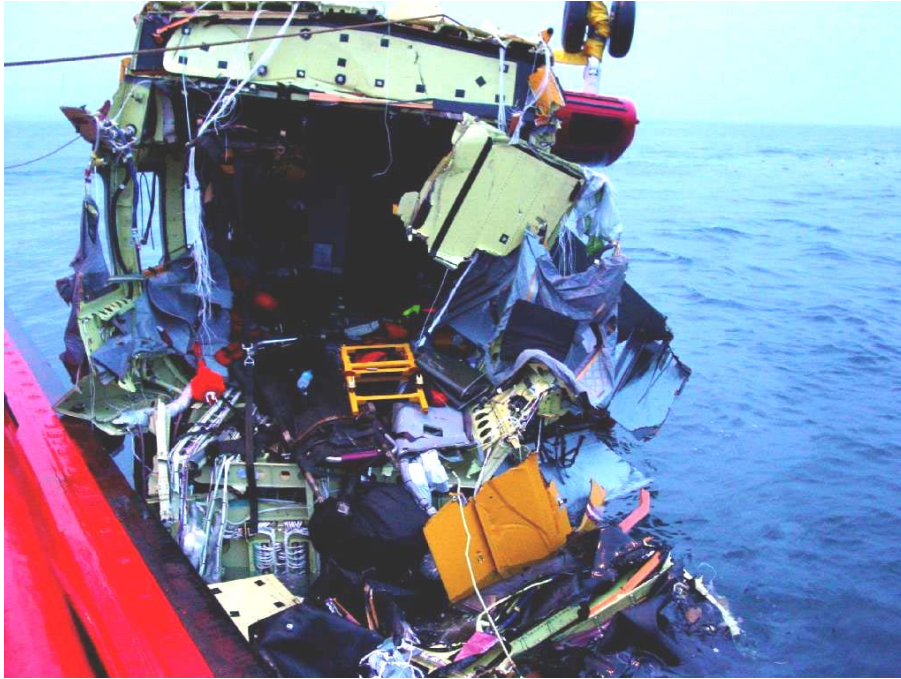
Photograph 3: Damage to the front of CH149914

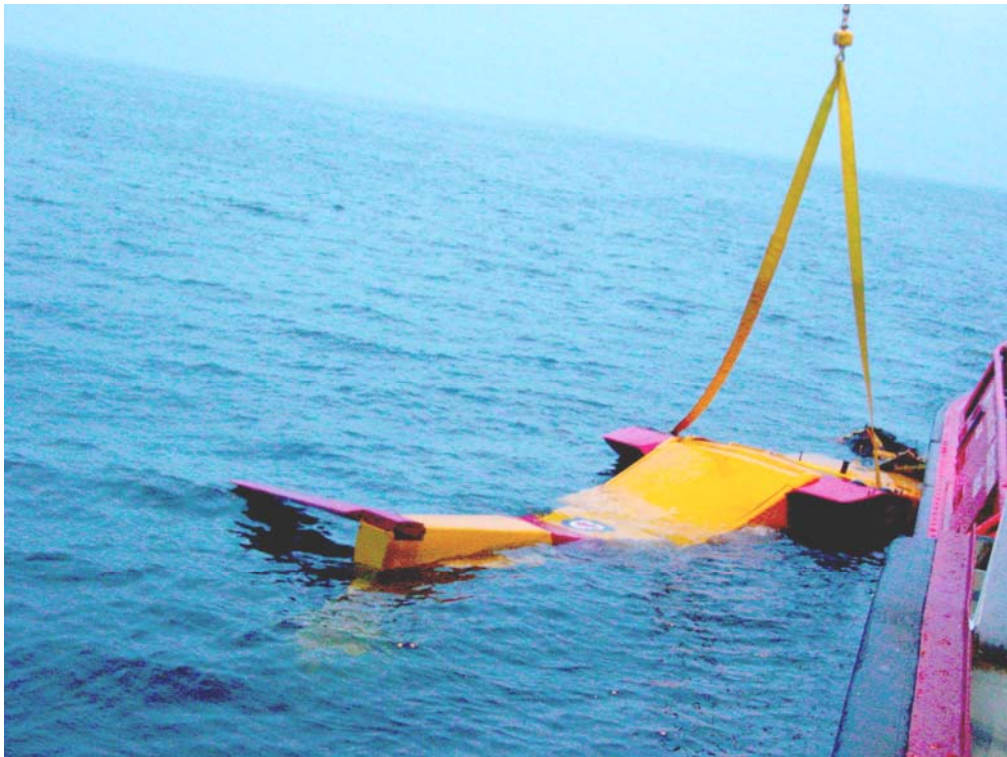
Photograph 4: CH149 floating inverted, tethered to the CCGS Earl Grey

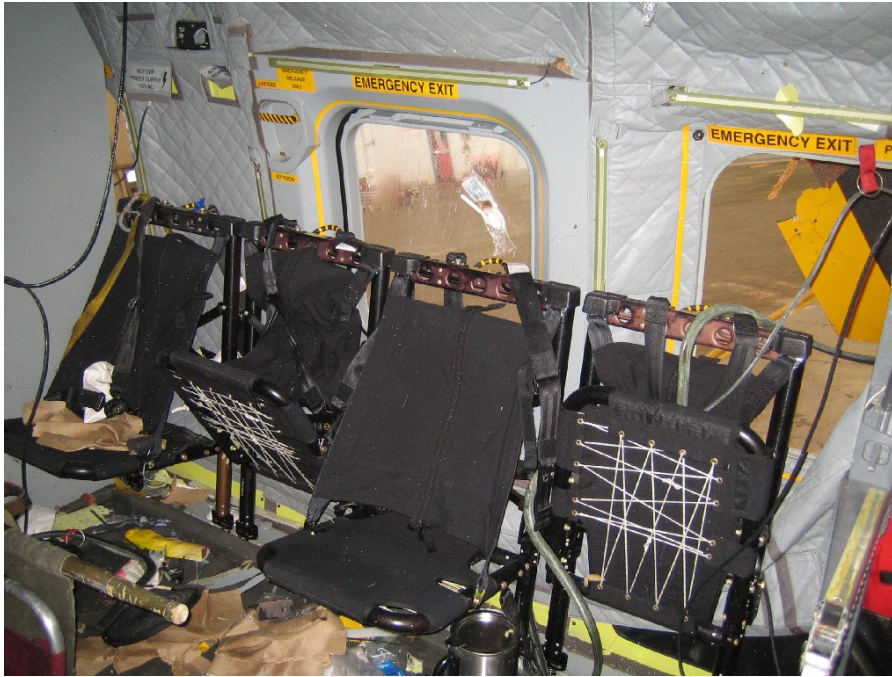
Photograph 7: Secondary exits partially blocked by passenger seats.

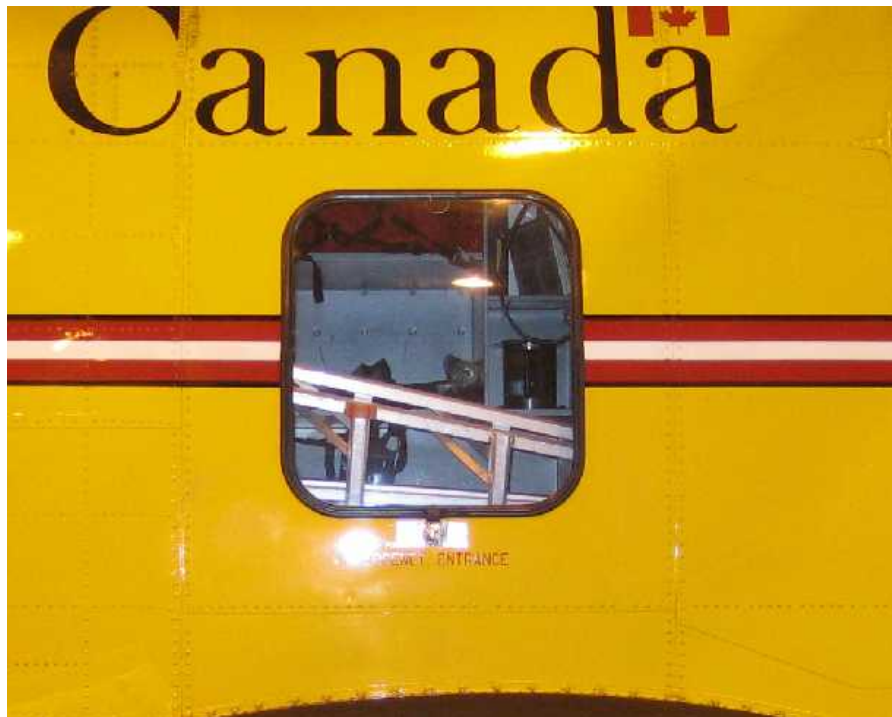
Photograph 8: Secondary exit with external view with the ladder positioned as it was found, blocking the exit in CH149914

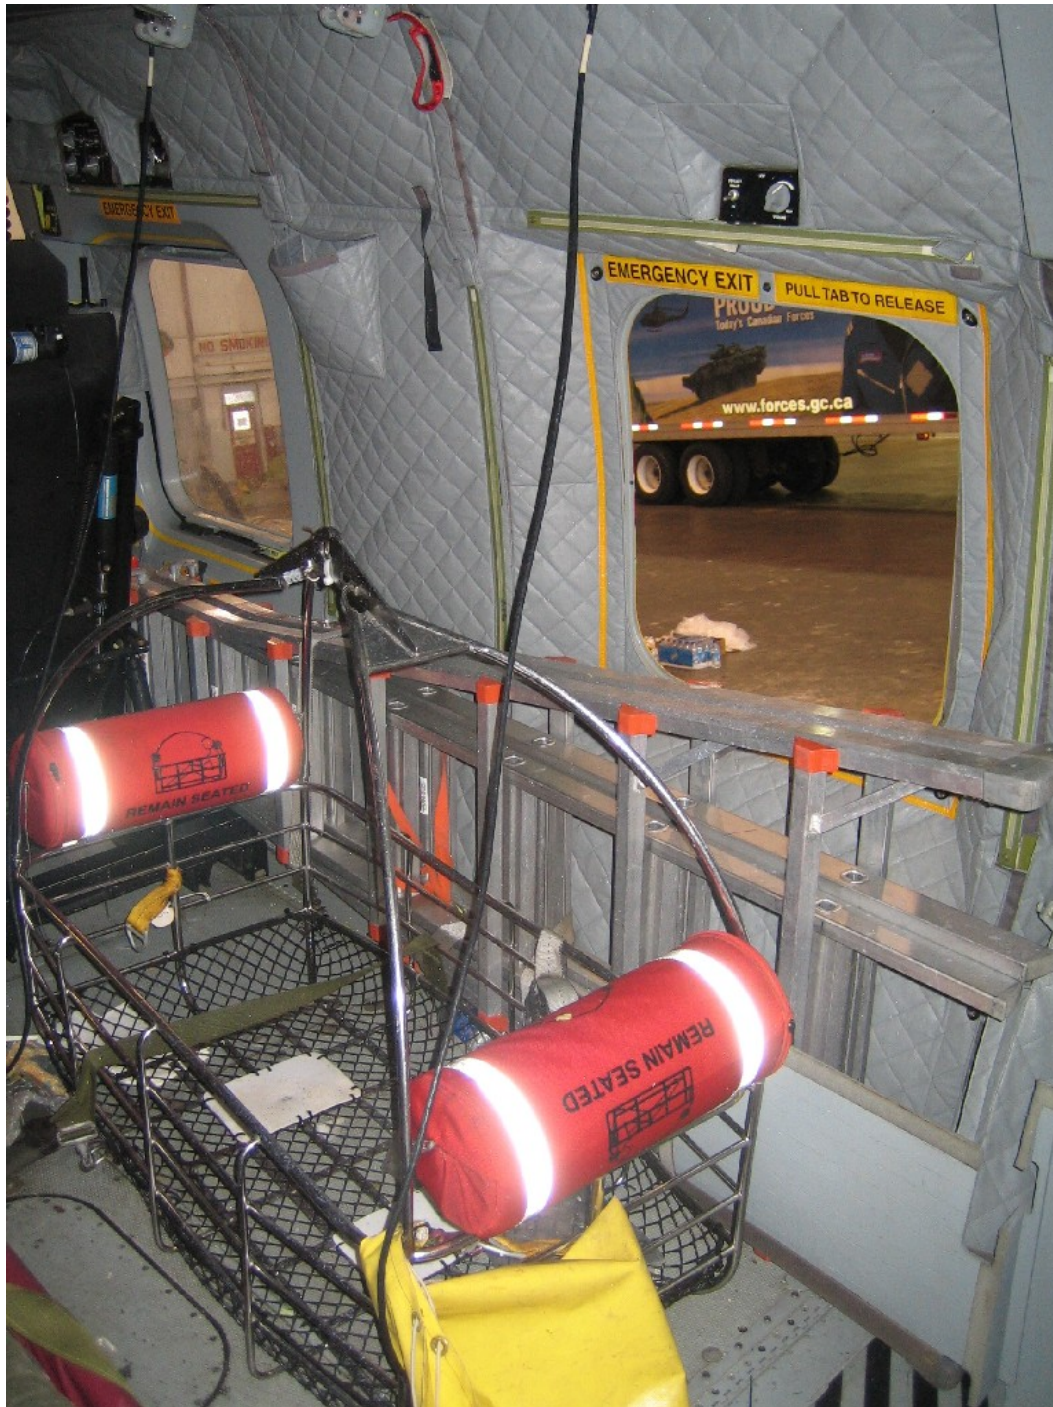
Photograph 9: Secondary exit (in the foreground) with the maintenance ladder and rescue basket stowed beneath it. Note HEELS lighting around the exit. The window release pull tab is hidden behind the ladder.
