**CANADIAN FORCES
FLIGHT SAFETY INVESTIGATION REPORT (FSIR)**

FILE NUMBER: 1010-149914 (DFS 2-3)
DATE OF REPORT: 22 January 2008

AIRCRAFT TYPE: CH149 Cormorant
DATE/TIME: 0330Z/0030L 13 Jul 06
LOCATION: Over Chedabucto Bay, 2nm north of Canso, NS
N45 22.0 / W061 00.4
CATEGORY: "A" Category Accident

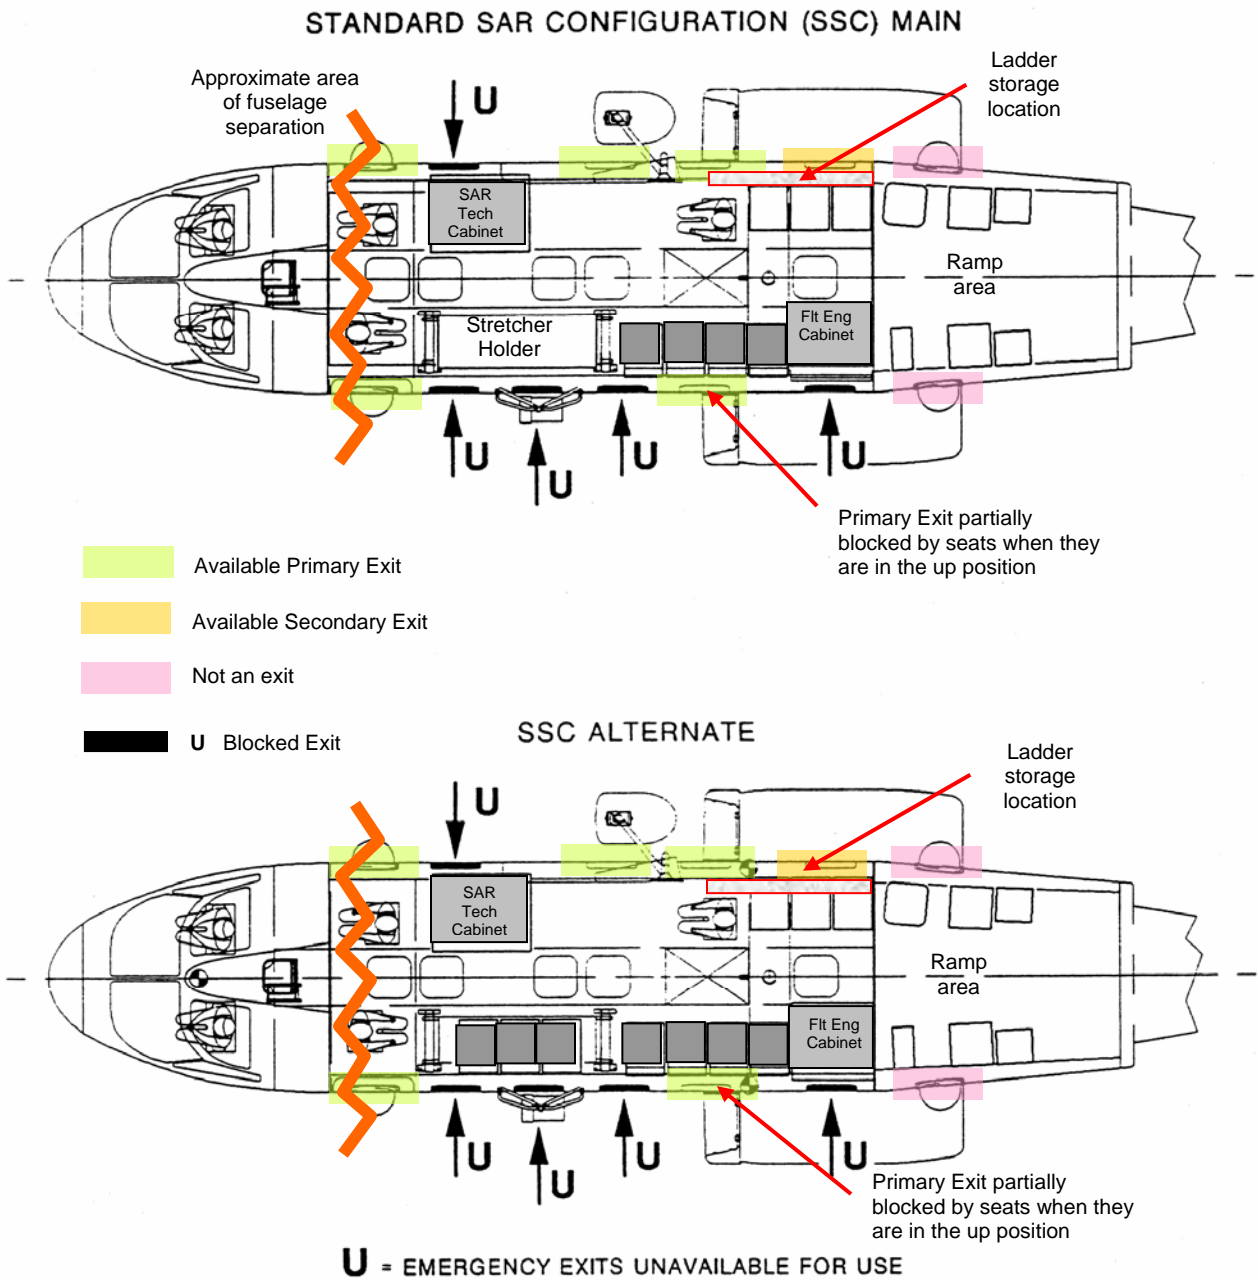
CH-149 Cabin Configurations

that in the Standard SAR Configuration all secondary exits on the left side of the cabin are blocked or unavailable and the forward secondary exit on the right side is blocked (see Annex B). The impediments to the secondary escape routes included hard mounted items such as the passenger seats, stretcher holders and the Flight Engineer and SAR Tech storage cabinets. All primary exits are normally available, however, the four fold down passenger seats in position aft of the stretcher are a significant obstacle should either the left hand secondary escape windows or left rear primary escape window be required. The seat backs, when left in the normally installed position, partially block the windows [Photo 7]. When lowered, these same seatbacks cover floor space required for placement of the stokes litter or rescue basket. The rear secondary exit on the right side of the cabin is partially blocked by the ladder, which is stored lengthwise on the cabin floor below the exit [Photo 8 and 9]. The rescue basket is also stored on the floor in front of this exit, beside the ladder. Despite the above noted impediments, in the Standard SAR Configuration, the CH149 exceeds the Joint Aviation Requirements (Europe) and Federal Aviation Requirements 29 (US) approved requirement for emergency exits in the cabin area of the helicopter.

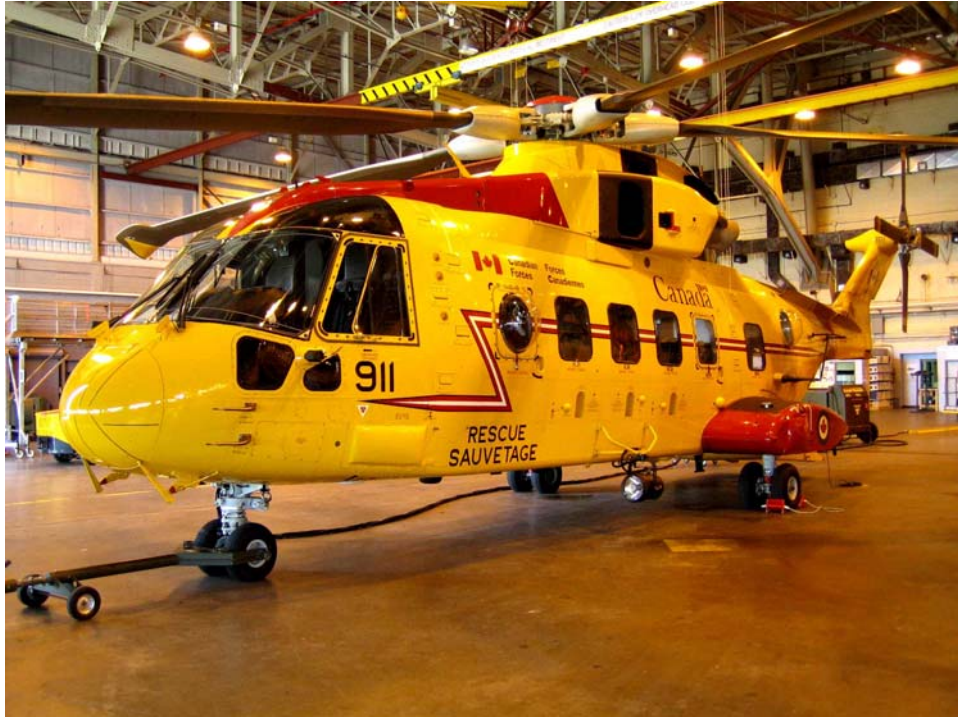
Photograph 1: A CH149 Cormorant

The CH149 Cormorant is the Canadian Forces' variant of the AgustaWestland EH101 all-weather, day and night operational, multi-role, medium-lift helicopter [Photo 1]. The helicopter airframe makes extensive use of composite materials.

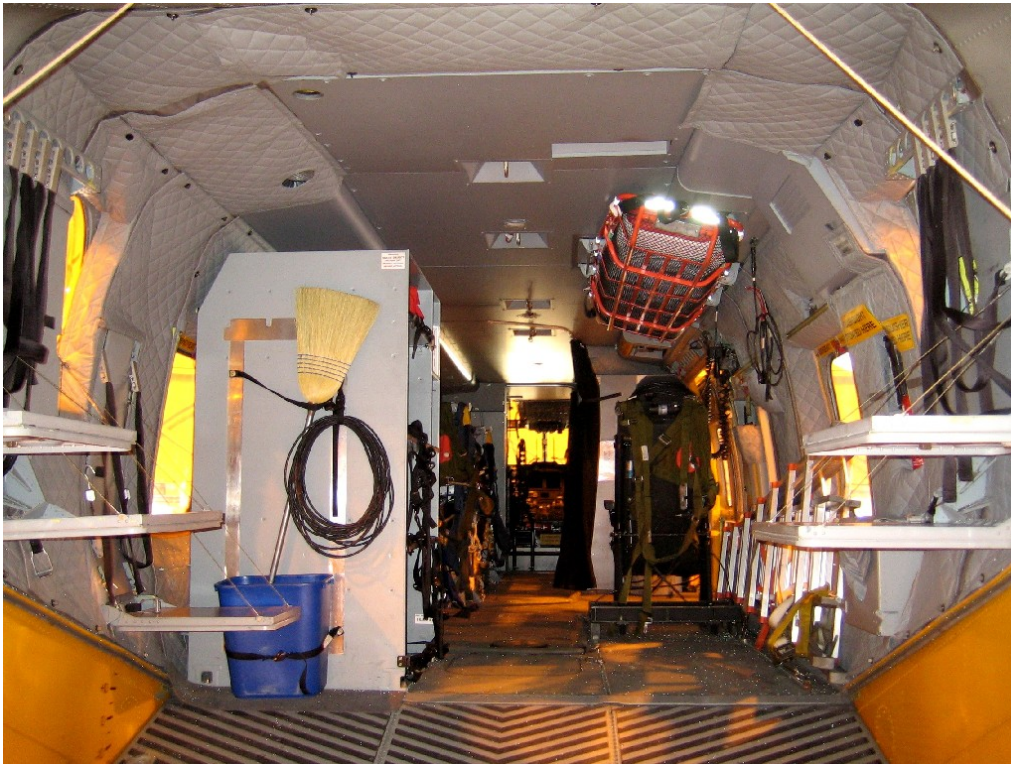
By the very nature of its demanding role the CH149 is required to routinely carry a great deal of equipment [Photos 5 and 6]. The Aircraft Flight Manual identifies

Photograph 5: Typical SAR Cabin configuration of the CH-149 (looking forward from the back of the cabin)

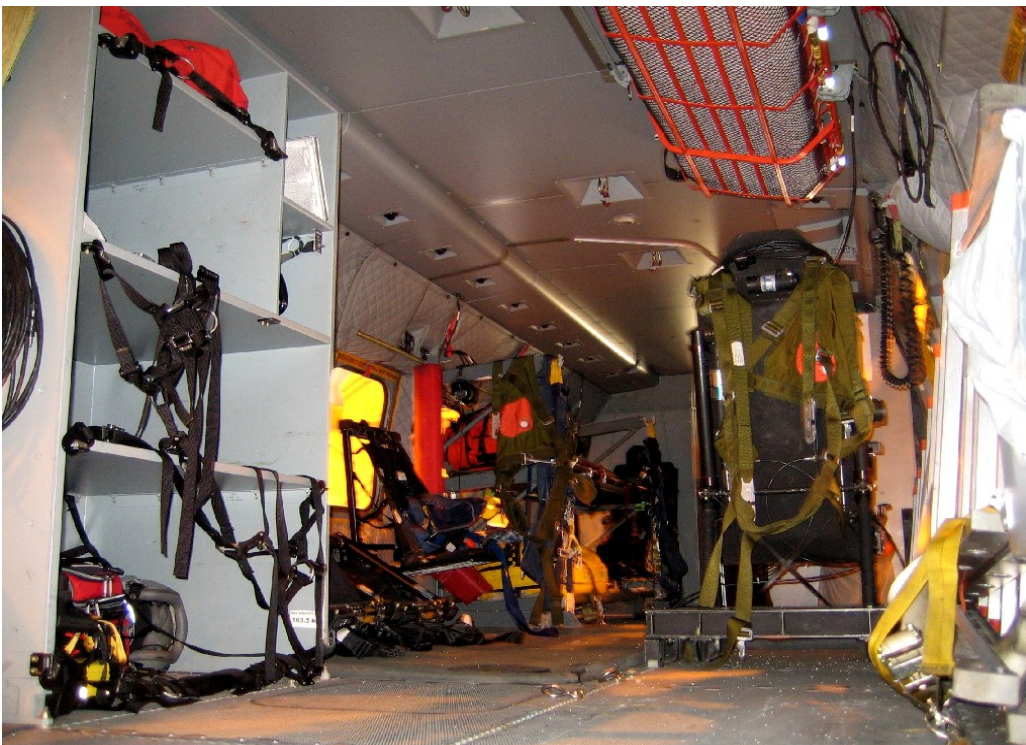
Photograph 6: Standard SAR configuration layout, looking at the left side of the cabin.

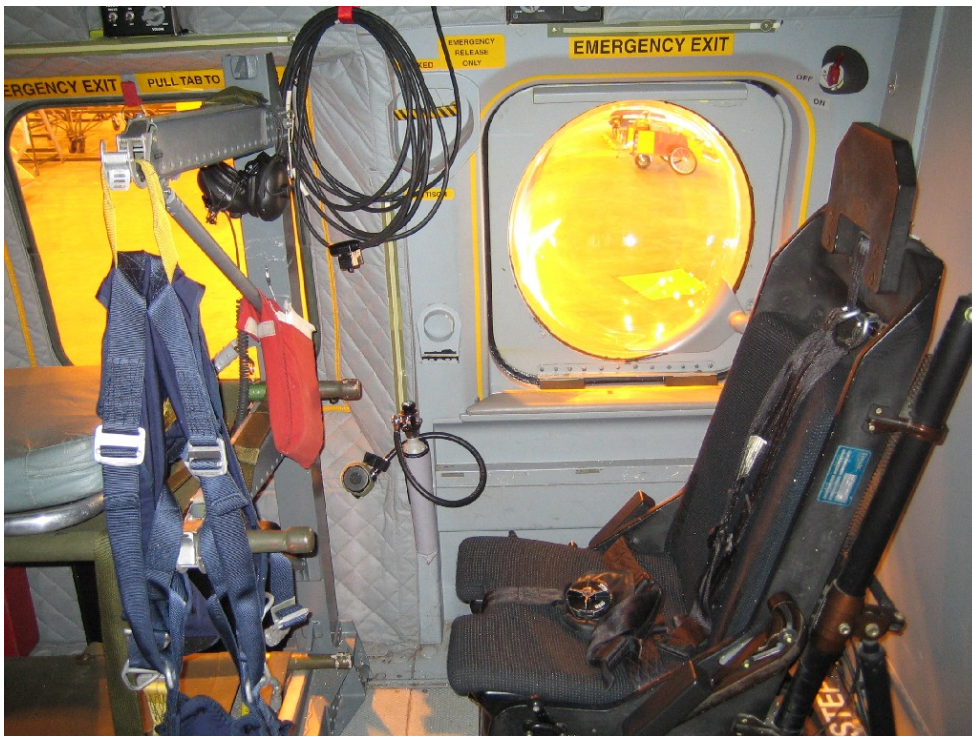
The FE's EBS cylinder was found with his LP/SV but out of its storage pocket. It was empty. The FEUT's EBS assembly was found unattached to his LP/SV and empty. EBS assemblies are not compatible with the SAR Tech floatation vests so theirs were stored at their respective crew seats. Of the two EBS assemblies assigned for use by the SAR Techs [Photo 10], one was found in the wreckage with the cylinder empty and the glass on the pressure gauge cracked. The other EBS assembly was not recovered.

Photograph 10: SAR Tech seat beside the left side forward primary exit. Note EBS bottle located to the lower left of the window.

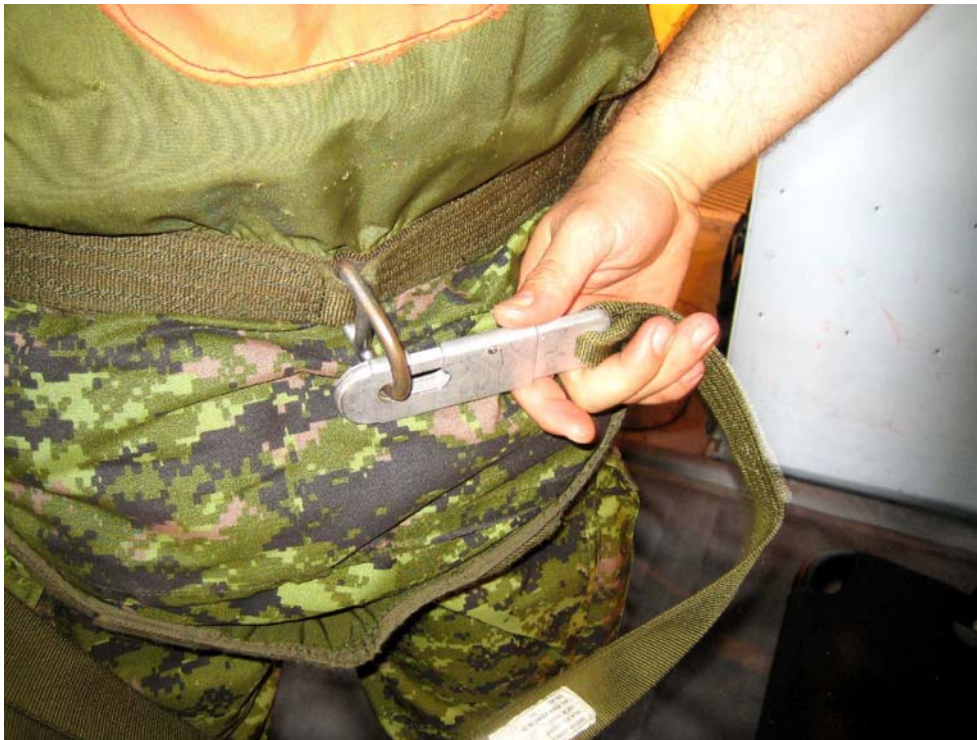
The crewman's safety restraint harness is designed to provide maximum safety to the wearer while working near an open door, hatch, or ramp of an aircraft in flight (e.g. during hoisting). The harness is constructed of standard parachute harness nylon webbing and metal fittings with additional attachment points for various tethers. A D-ring is fastened to the rear waist strap for attachment of a static line anchor strap ("monkey tail") to allow movement around the cabin. The length of the anchor strap is adjustable. The harness does not incorporate a quick-release capability. The anchor strap attachment on the back of the harness can be set up for either a right or left hand release [Photo 11]. The release cannot be activated if the strap is under tension. The other end of the anchor strap is attached to one of four hard points located in the ceiling of the cabin area.

Photograph 11: Anchor Strap attachment point to restraint harness.
